Manhole Inspection Summary

Manhole # S17KK1004MH

Insp Date: **7/12/07 11:20 AM**

Location Address: **GREEN SPRING AVE**

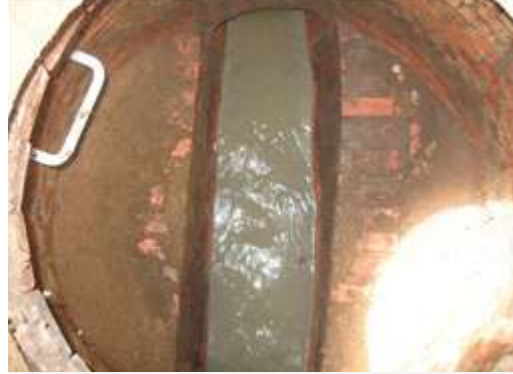
Top View

Evidence of surcharge - Bench debris.

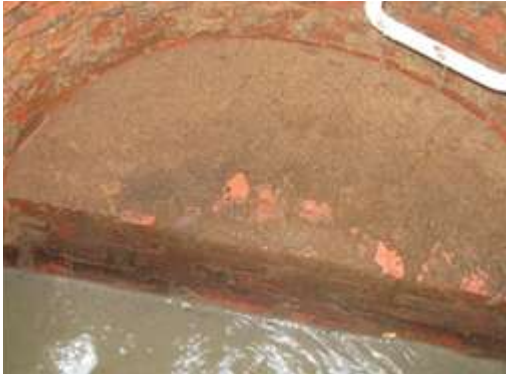
Defect

Barrel infiltration.

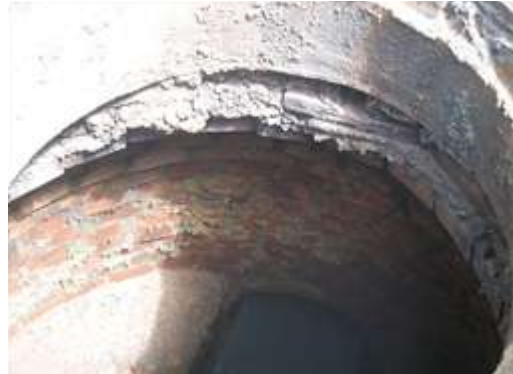
Defect

Frame leaks. Adjustment deterioration, loose brick and infiltration. Corbel and Barrel infiltration.

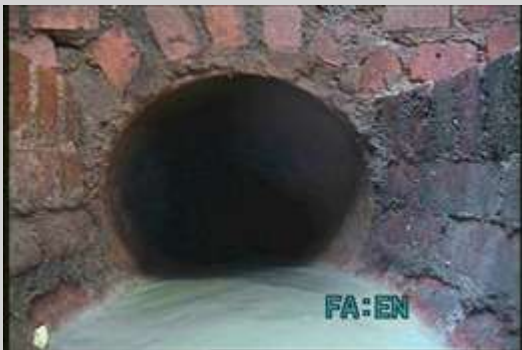
15 in. Circular Gravity Sewer Pipe Out @ 12 O'Clock

Infiltration: **None** Pipe Seal Cond: **Unknown**

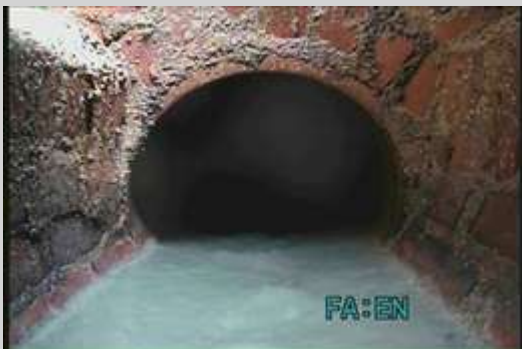
15 in. Circular Gravity Sewer Pipe In @ 6 O'Clock

Infiltration: **None** Pipe Seal Cond: **Unknown**
